Subject: Heavy-Duty Solo Clutch - Low Stabilized Bearing Position with Hydraulic Release Systems

Document Number: CLIB0027

Date: December 2, 2013

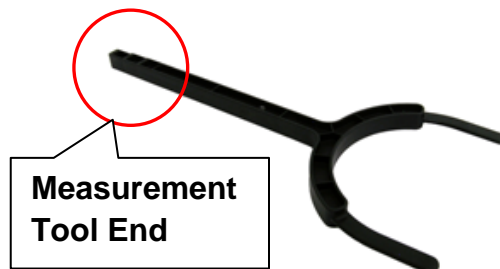
Note: The K-Line tool is acceptable for a quick check to see if the HD Solo clutch release bearing travel is within the 0.490" to 0.560" specification. Measure the distance at the bottom of the release bearing, if the gauge does not fit, then the clutch bearing travel is less than 0.490 inches.

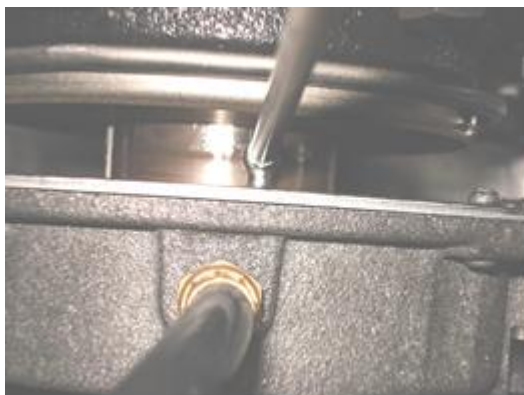
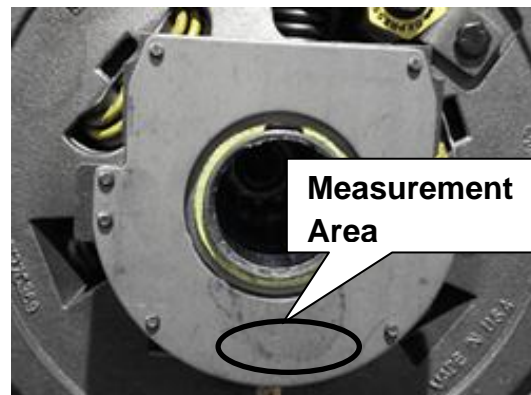
1. Recommended Approach: Use appropriate telescoping gauge or transfer caliper to measure the distance between release bearing and clutch brake.
 - **Note 1:** Measure gap at the bottom of the release bearing and verify that a light drag is felt while sliding the telescoping gauge or transfer caliper from side to side.
 - **Note 2:** Be sure the clutch brake is contacting the bearing cover on the transmission.

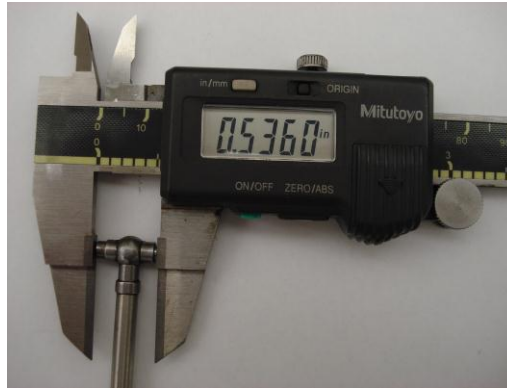
2. Measure the telescoping gauge or transfer caliper with the digital Vernier caliper to see what the gap is between the release bearing and the clutch brake.
