Subject: Pilot Bearing Spacer 02-14069-000 – Detroit Diesel Engines

Document Number: TAIB-0854

Date: January 6, 2015

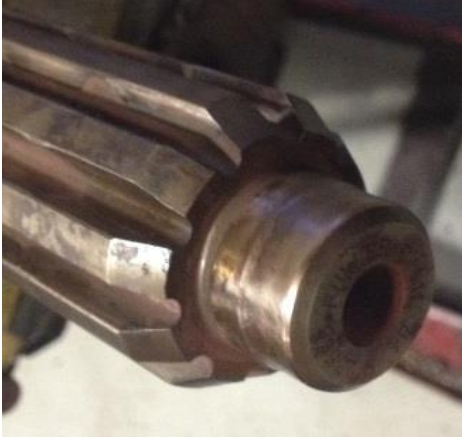
Issue Description: Reduced transmission input shaft support caused by insufficient engagement of the pilot bearing on Detroit Diesel engines.

Worn input shaft pilot surface

- Install spacer 02-14069-000 between the flywheel and a new pilot bearing when the transmission is removed for service work.
- Inspect the transmission input shaft pilot surface and oil return threads (see picture below). Replace the input shaft if there is evidence of any wear at these locations or the transmission was leaking oil at the front bearing cover before it was removed.
- Replace the transmission front bearing cover if the input shaft oil return threads are damaged.
- Remove shift bar housing and inspect the main drive gear set for tooth damage before placing the transmission back in the vehicle. Replace any damaged gearing.

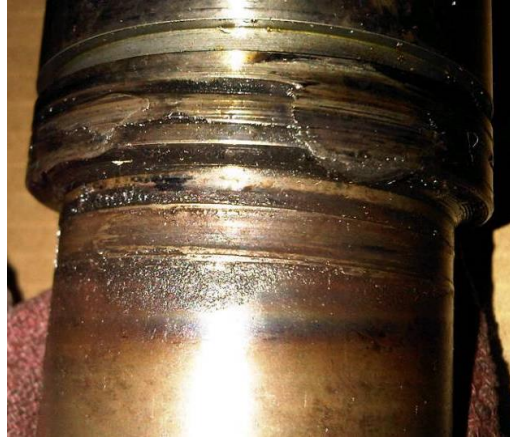
Damaged oil return threads
