Subject: Shift Complaint After Installing New XY Shifter – Gen 3 Product

Document Number: TAIB-0858

Date: September 24, 2015

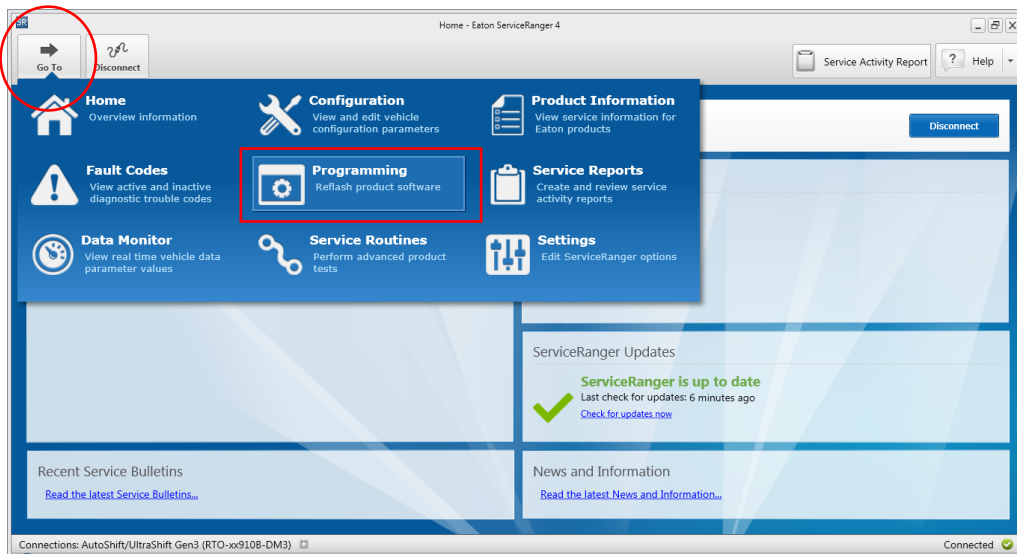
Issue Description: Transmission fails to engage a start gear or has shifting related issues immediately after the XY shifter has been replaced and calibrated.

1. Connect ServiceRanger to the vehicle
2. Click on “Go To” in the upper left corner, then “Programming”.
