Subject: ECA Clutch Incompatible Lube Failures

Document Number: CLIB0030

Date: February 6, 2017

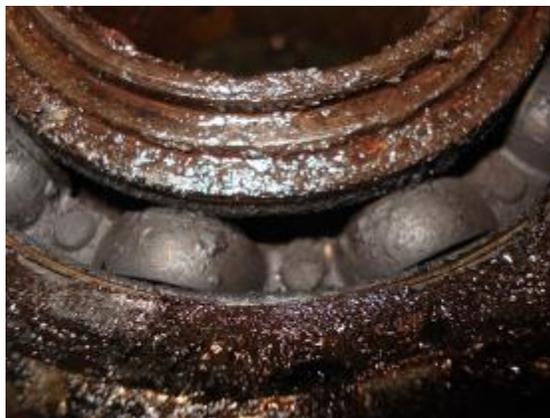
Issue Description: The ECA clutch (PN 122002-35, 122003-42) uses a sealed bearing in the release bearing housing. Testing has shown that some service greases used during maintenance intervals have ingested past the seals into the release bearing during normal operation. Ingested service grease mixes with the sealed bearing grease and may cause an incompatible lube failure.

Typical evidence of an incompatible lube failure is dry or hard clumped material inside the release bearing and/or the release bearing housing. The unit may or may not have fresh grease in the bearing area. See Figure 1.

Figure 1: Incompatible Grease Failure

Symptoms of the failure in Eaton Automated product are Fault Code 27 FMI 7 for Inertia Brake Touch Point < 16°. As the bearing fails due to lack of lubrication, it seizes. The now spinning outer race wears into the bearing housing stand offs, or the release bearing sleeve wears into the spring retainer of the clutch. This wear reduces the distance between the back of the release bearing and the LCIB. This is a latching fault that cannot be cleared. The clutch must be replaced.

1. Replace clutch with correct part number. Use Heavy-Duty Clutch Service Manual (CLSM0200) for proper installation procedures.
2. Clutch replacement will be covered under warranty.
3. Requirements for coverage are:
 - SAR Showing FC 27 FMI 7 with IBKTP < 16°
 - Photographic evidence of release bearing housing
4. Eaton will educate fleet to use grease that is appropriate for release bearing applications. (See Service Bulletin CLIB0029.)
5. Repeat release bearing failures after incompatible lube failure identification on the same vehicle (VIN) will be considered non-warrantable.
