Subject: Engine Flywheel Housing Requirements and Fault Code 250 – Endurant Transmission

Document Number: TAIB-0878

Date: July 22, 2019

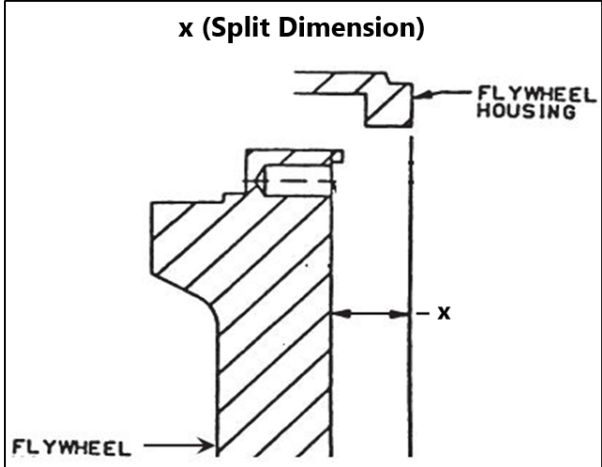
The Endurant Transmission requires a specific engine flywheel housing to ensure the correct Split Dimension. The Split Dimension is the distance from the engine flywheel machined surface to the engine flywheel housing where the transmission clutch housing attaches.

1. If the engine or engine flywheel housing requires replacement, contact the OEM and/or engine manufacturer to identify the engine flywheel housing part number based on the transmission model.
2. To verify the correct engine flywheel housing is installed, measure the Split Dimension and reference the chart below:

Endurant Transmission			
OEM	Engine	x (Split Dimension)	
		mm	in
Navistar	A26	65.70-67.59	2.59-2.66
Navistar	X15	65.70-67.59	2.59-2.66
PACCAR	X15	65.70-67.59	2.59-2.66
