## Service Bulletin: TMIB-0144

**Topic:** Loose Output Nuts on Low Mileage Transmissions

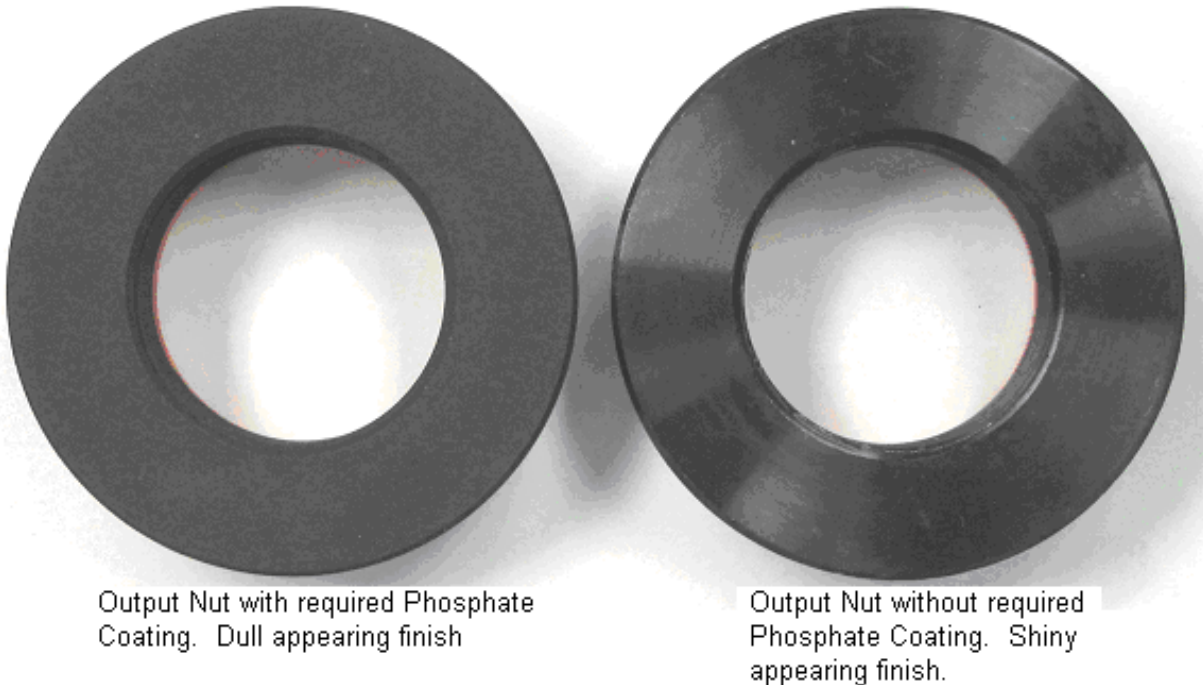
## Output Nut with vs. without phosphate coating

The output nut missed a required process, which applies a phosphate coating to allow lubrication between the flange face of the nut and the output yoke during the tightening process. Friction between the nut and output yoke may give a false reading of torque when tightening the output yoke nut.

Output Nut with required Phosphate Coating. Dull appearing finish

Output Nut without required Phosphate Coating. Shiny appearing finish.

When installing an output nut that is suspect of not having the phosphate coating a small amount of oil or grease should be applied to the flange face of the output nut before installing. If unsure which output nut you have grease should be applied to ensure proper tightening

1. Remove output nut
2. Inspect threads on output shaft for damage. (If damage is present replace auxiliary output shaft. Follow repair procedures for R&R and disassembly/assembly of auxiliary section).
3. Apply grease to flange face and threads of a new output nut.
4. Tighten output nut to 500 lb ft.
5. To ensure output yoke is tight attempt to spin speedo rotor.
