Eaton Corporation  
Truck Components Operations – North America  
P.O. Box 4013  
Kalamazoo, MI 49003

**Topic:****Shift Tower O-rings**

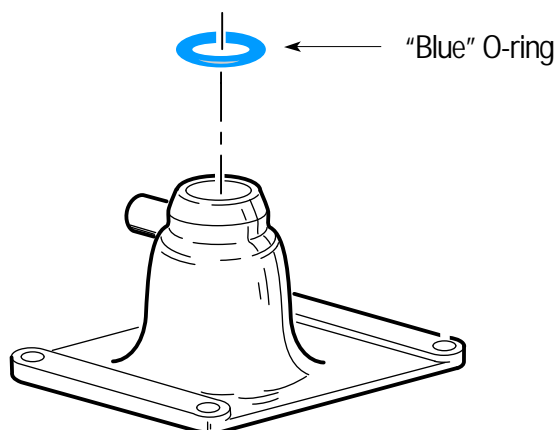
The shift tower O-ring used in Eaton® Fuller® transmissions is color coded to distinguish it from other O-rings that can deteriorate over a period of time. The O-ring color used in Fuller transmissions is blue. The non-approved O-ring is black.

Lever entrapment can be caused when the black O-ring deteriorates to a point where the shift lever finger is allowed to come out of the shift blocks. With the shift finger outside the shift blocks the lever will move around, however, the driver is unable to shift. The transmission will stay in whatever gear was chosen previous to the lever coming out of the shift blocks.

Excessive heat to the shift tower area can damage either colored O-ring. If the exhaust pipe is routed too close to the shift tower or if using a torch to bend the lever, the O-ring can soften and sometimes melt allowing excessive movement in the shift tower.

To correct this problem, remove the shift tower from the transmission, remove and discard the black O-ring, insert a new blue O-ring and re-install the tower. The part number of the blue O-ring is 4301211. If the new O-ring you receive is black, return it to your supplier and insist on the blue colored O-ring. The black O-ring part number is 17162 and is sometimes packaged under the wrong part number.
