Subject: Worn Shift Fork and Sliding Clutch Wear on Automated Transmissions

Document Number: TAIB-0818

Date: December 16, 2010

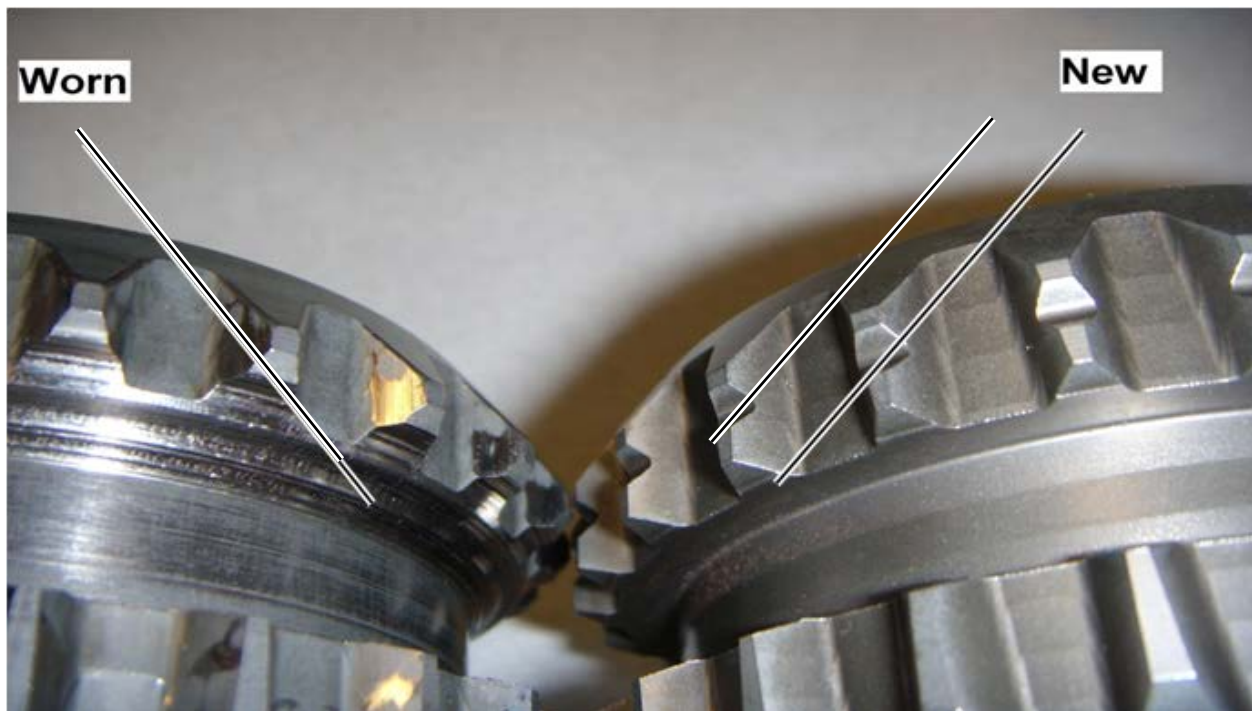
The yoke and clutch may be worn on both sides; primary wear will be on the direct side only. The issue is addressed in software version 890 and higher.

Note: This may be inspected thru the 8 bolt PTO opening. Notice the sliding clutch has worn all the way back to the original center groove.

Drain lube, remove 8 bolt PTO cover/ inertia brake and inspect for wear on the front sliding clutch per picture attached. Replace worn components and update to the latest software version.
