Bulletin: TAIB-0831

Date: March 19, 2012

Subject: Loose ECA Connectors in UltraShift® *PLUS* Models

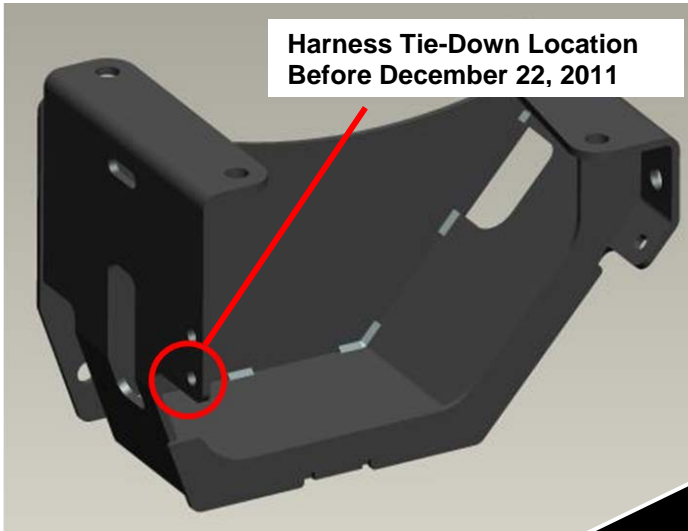
Old Style ECA Shield

One or both of the ECA connectors (3-way and/or 8-way) may be loose; causing ECA related faults to occur:

- ECA 3-way and 8-way connectors may not fully seat and latch.
- Transmission harness routing may lead to excessive side loading of the ECA connectors.

Tie-wrap the ECA 3-way and 8-way connectors with zip ties on units that have the old style ECA shield used before December 22, 2011.

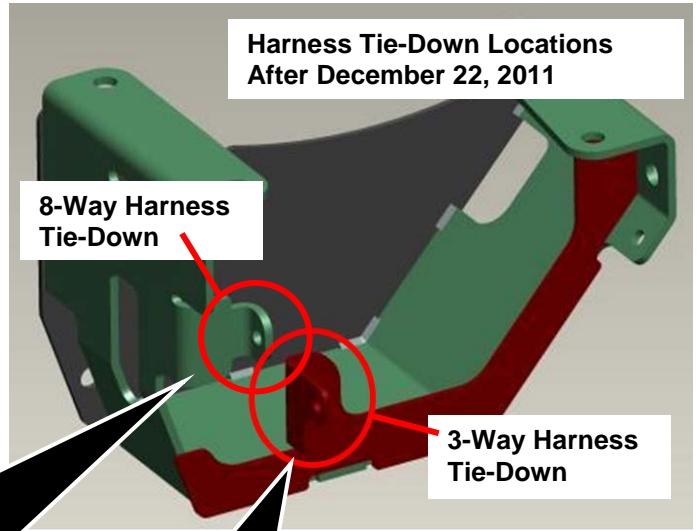
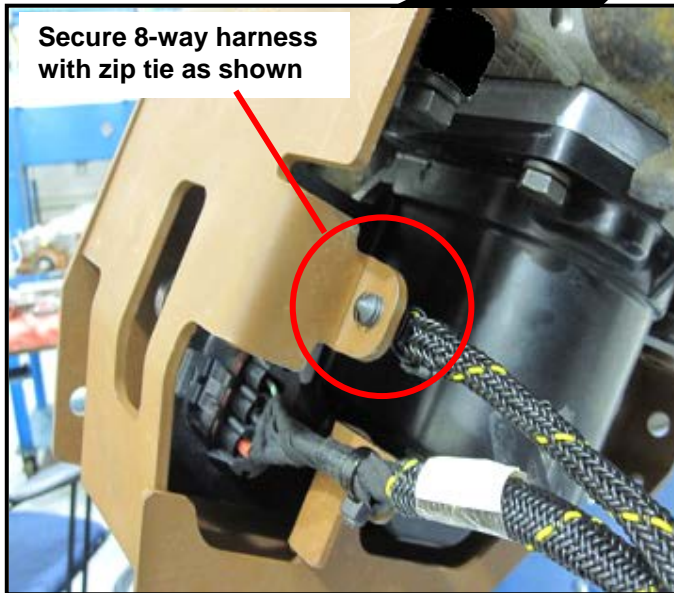
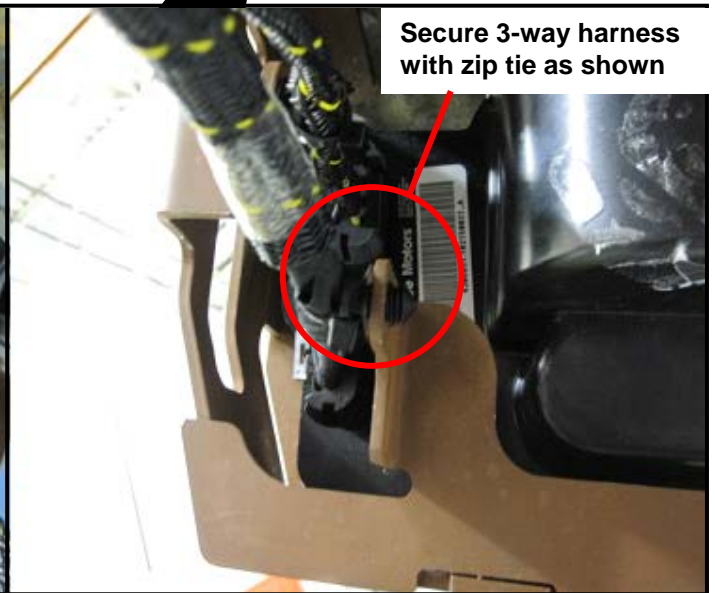
Current Style ECA Shield

The current style ECA shield has been revised to improve harness routing and eliminate side loading of the ECA connectors on transmissions built after December 22, 2011.
