**Subject:** Oil Leak Around the Filter, Filter Housing and Cooler Lines on UltraShift® PLUS Models

**Document Number:** TAIB0834

**Date:** September 21, 2011

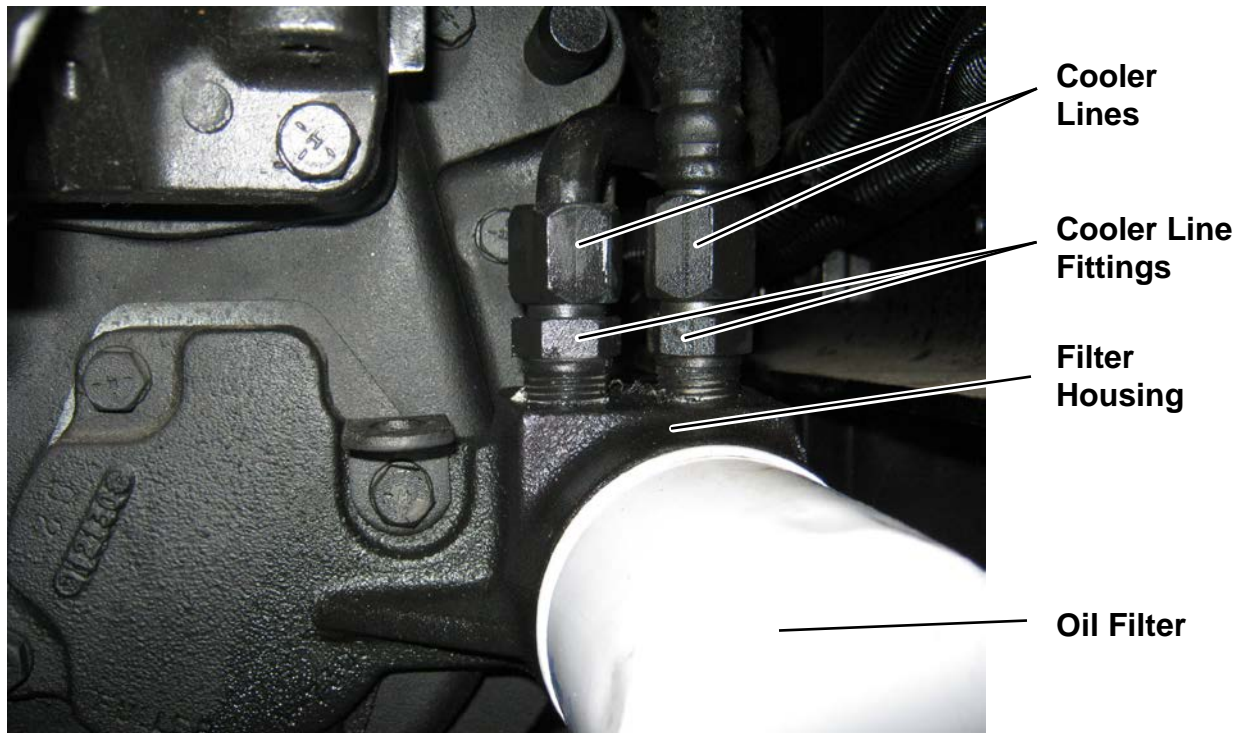
UltraShift PLUS transmissions built before July 18, 2012 have been reported with oil leaking around the filter, filter housing and cooler lines.

Oil leak discovered by a visual inspection of oil filter, filter housing and cooler lines

If oil is leaking from around the oil filter, filter housing or cooler lines, repair as follows:

1. Clean the area near the origin of the leak to determine the source.
2. Document the leak source.
3. Repair the oil leak as required.
4. Top off the transmission with oil.

**Note:** After the repair is completed, verify the leak is repaired and operate the vehicle to normal operating temperature. Inspect repaired area to ensure oil leak has been eliminated.
