Subject: Fuller Advantage Lube Tube Misconnection

Document Number: TAIB0851

Date: July 1, 2014

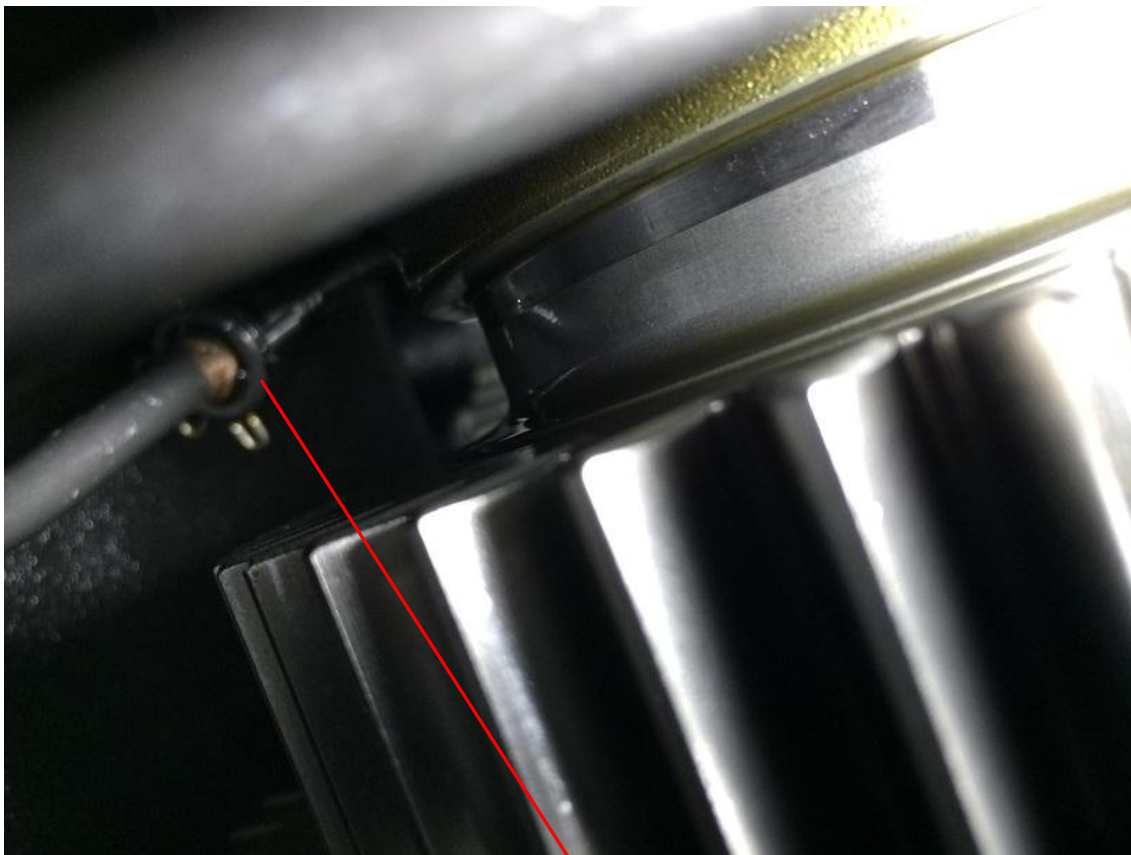
- This picture is a view through the 8 bolt PTO cover looking up at the connection point.

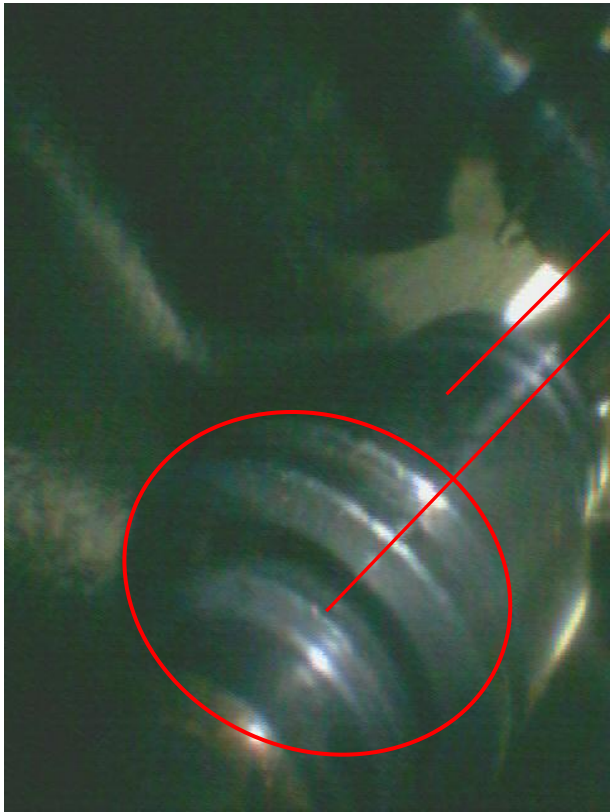
The connection point of the lower idler feed tube to the upper idler feed tube.

Slip Collar

Ferrule

This is an improper connection with the slip collar not fully seated over the ferrule.

- Proactive inspection
- If the connection is identified with the slip collar on the upper idler feed tube not seated fully over the ferrule of the lower idler feed tube then proceed with the corrective action.

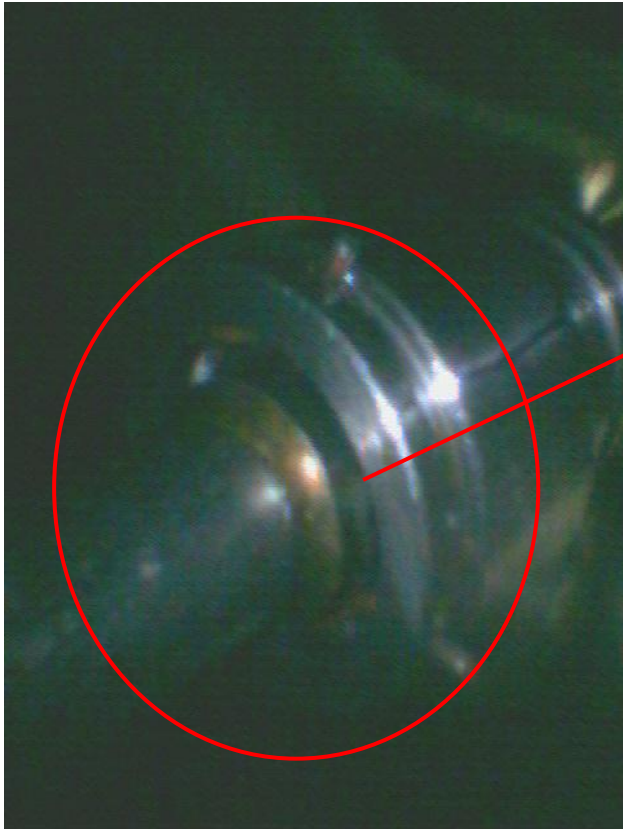
- This is a proper connection with the slip collar fully seated over the ferrule and the spring clip locked in place.
- The lower idler feed tube boss of the ferrule will be flush with the slip collar.

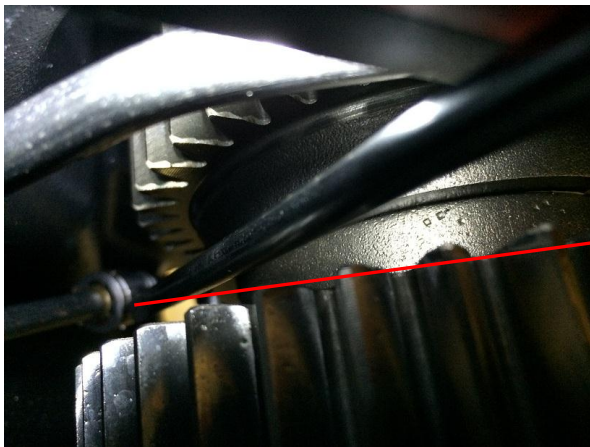
- Screw driver blade pushing on the slip collar to verify it is locked in place through the 8 bolt PTO cover.
- When the screw driver is used make sure the spring retainer clip does not pop off.
