Subject: A-7786 Hydraulic Clutch Release Yoke – Improved Seal Retainer

Document Number: TAIB0853

Date: October 27, 2014

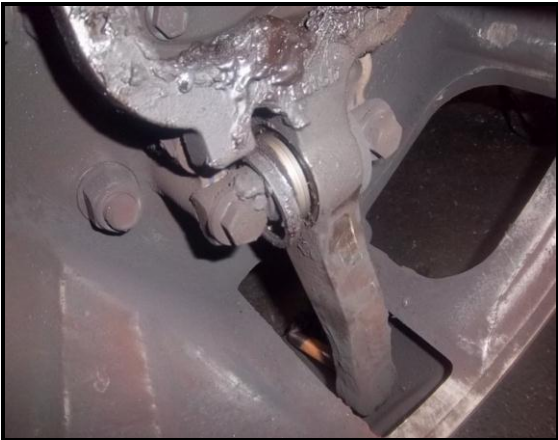
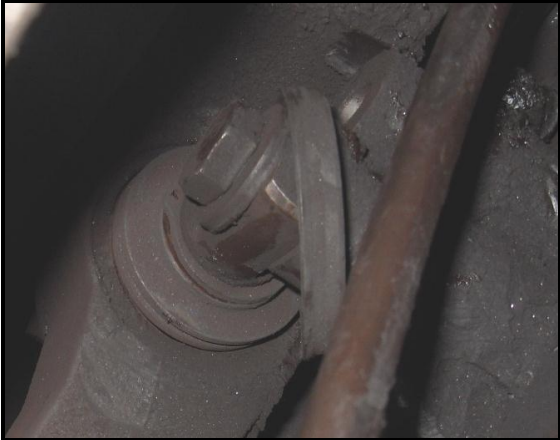
Issue Description: The integral hydraulic clutch release yoke assembly A-7786 contains two seals that keep clutch dust and contaminants out of the center pivot bearing area. Seals can become dislodged from the side spacer and fall down to the pivot shaft.

Field Strategy: Currently the release yoke is not serviceable. Replace with the complete service assembly A-7786 if the side seals are not in place or are damaged.

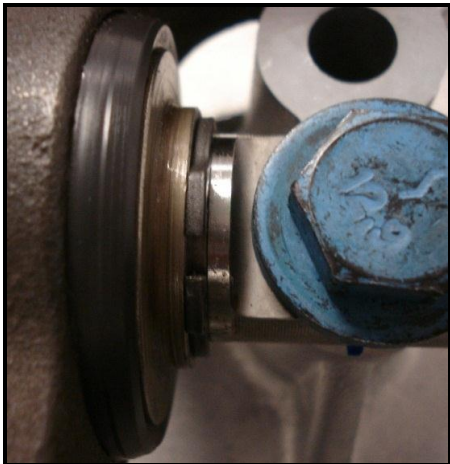
Previous spacer design

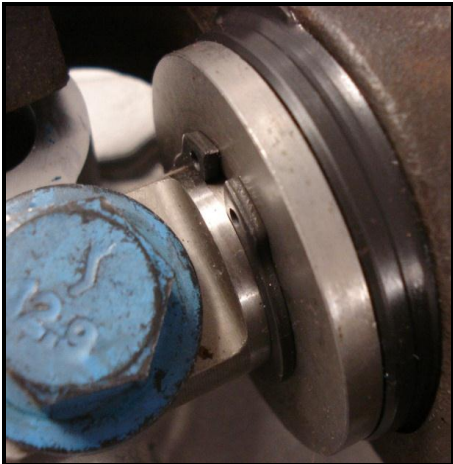
New spacer with raised seal retainer

Corrective Action: A new side spacer, with an increased shoulder diameter for improved seal retention, was implemented in production 09/18/2014. The service part number A-7786 will not change.
