Subject: External Mounted Heat Exchangers

Document Number: TAIB0859

Date: October 5, 2015

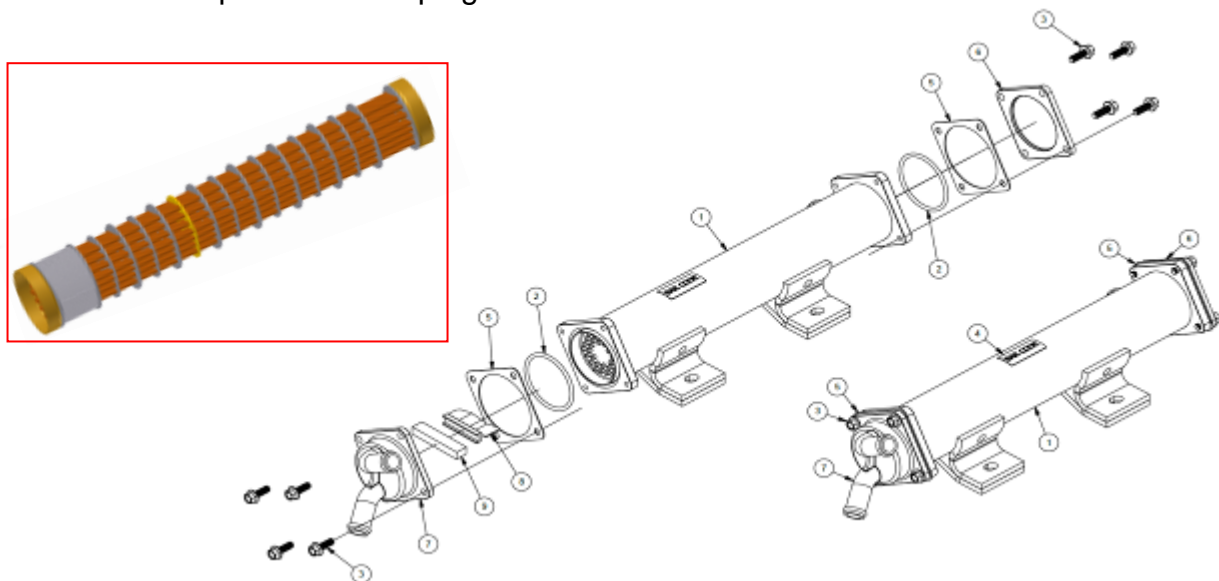
Eaton has released a new design heat exchanger replacing the below part numbers.

External cooler redesign will feature:

- Replaced fixed joint between the bundle and shell with full floating bundle style. This configuration will eliminate silver braze.
- Bundle supported in shell by O-rings that provide vibration isolation.
- Copper fins replaced with aluminum that eliminates the need for silver in brazing solder.
- Weight savings: 0.5 lbs.
- Flanged end bonnet design for coolant inlet / outlet configurations.
