Bulletin: TMIB-0193

Topic: Transmission Output Shaft Nut Loosening

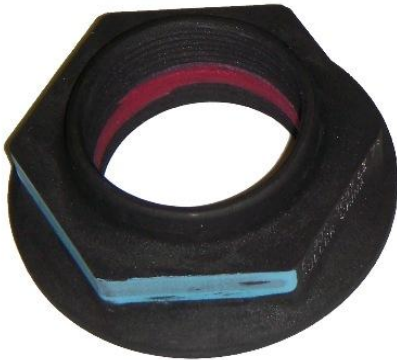
New Output Shaft Nut (4306520)

The new output shaft nut (4306520) will prevent loosening and maintain the installation torque. The new nut has a crimped crown that creates interference between the output shaft threads and the nut. In addition, there is a locking compound applied to the threads of the nut.

If output nut 4302321 loosens, replace it with 4306520 and torque nut to 650-700 lb-ft.

Note: The new nut with the crimped crown requires a higher torque rating than the old nut. The higher torque is needed to seat the nut completely.

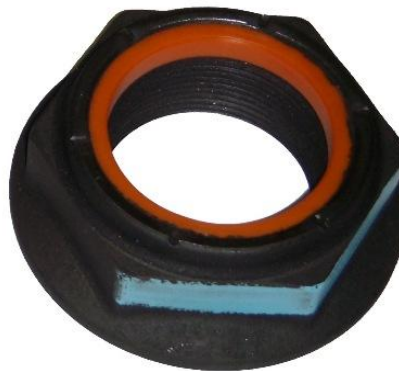
Current Output Shaft Nut (4302321)

The heavy-duty transmission output shaft nuts have been loosening.
