Bulletin: TMIB-0210

Subject: Reman Transmissions Assembled Without Splitter Snap Ring

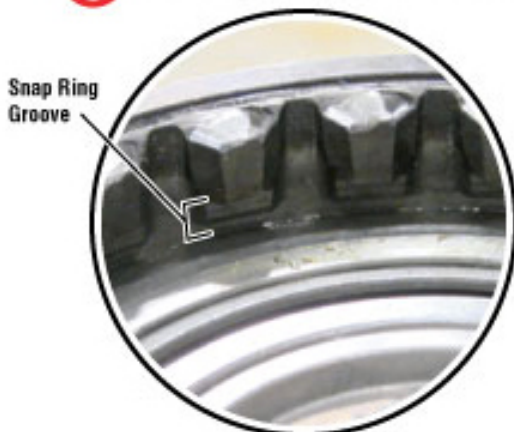
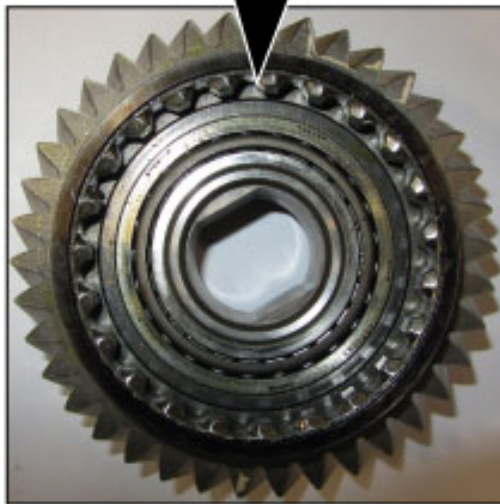
Issue Description: A number of Reman transmissions have failed due to not installing the splitter gear snap ring (4303424).

**Splitter Snap Ring - Missing**

Field Strategy: Fix as fails if installed or proactively repair if not installed.

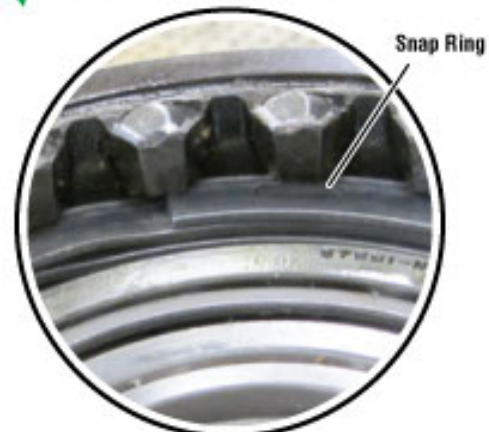
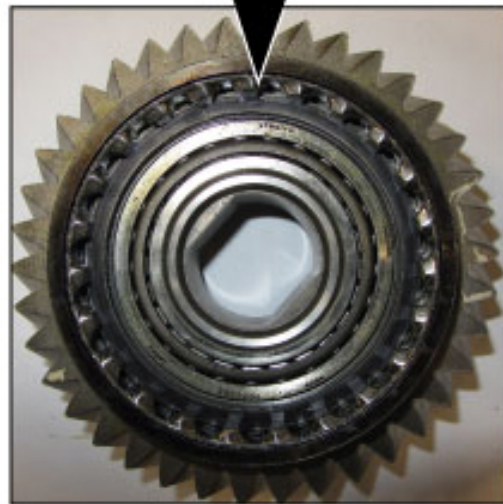
**Splitter Snap Ring - Installed**
